## Description

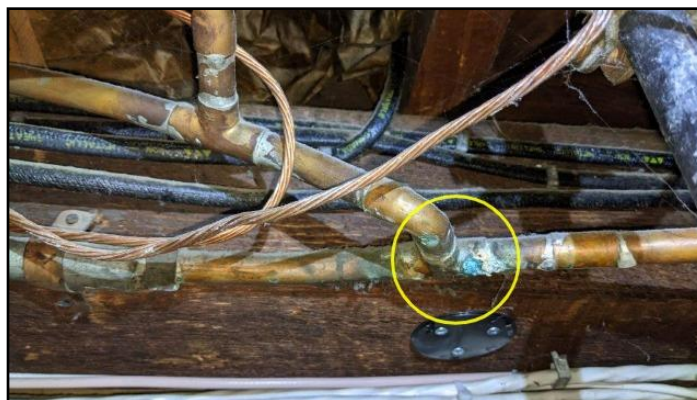
**36. Condition:** • Copper pipes older than 35 years, monitor for leaks, repair as necessary. Some corrosion noted on copper fitting. Not an active leak shown on picture.

*Copper pipes older than 35 years, monitor...*

**Task:** Monitor for leaks, plumber to repair leaking pipes

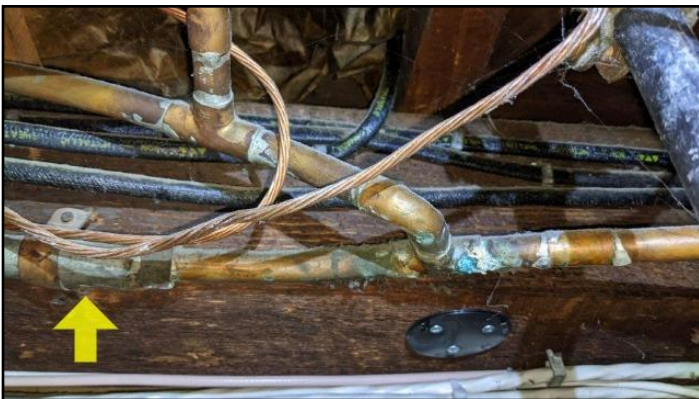
**37. Condition:** • [Galvanized steel](#)

Galvanized pipes are steel pipes that have been dipped in a protective zinc coating to prevent corrosion and rust. Galvanized piping was commonly installed in homes built before 1960. When it was invented, galvanized pipe was an alternative to lead pipe for water supply lines. Over time, the galvanized steel pipes begin to rust or corrode from the inside.

**Implication(s):** Reduced water pressure and volume

*Galvanized steel*

Have certified plumber evaluate the presence of galvanized steel material in water supply piping.

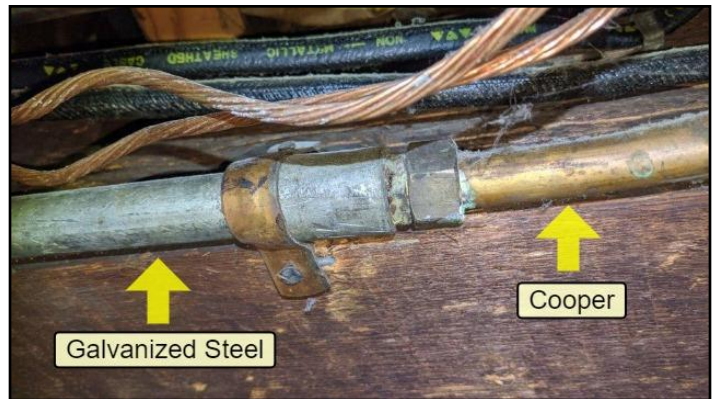
*Galvanized steel*

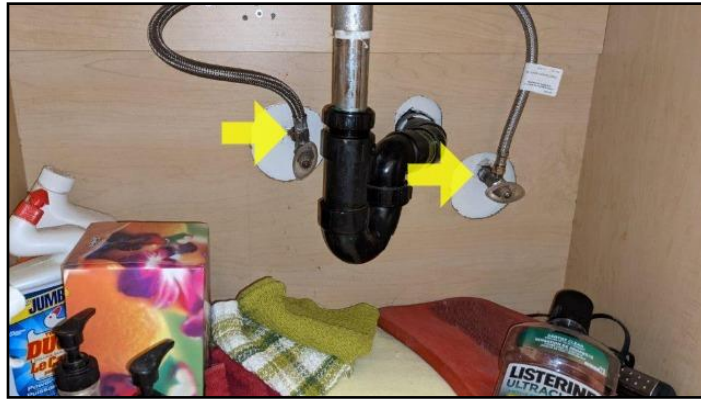
**38. Condition:** • Polybutylene

Noted in the basement bathroom under sink water supply polybutylene piping material. Poly B piping has a history of failing, consult a plumber regarding condition of piping and possible replacement. In addition, there may be possible insurance issue; consult with your insurance provider.

Polybutylene

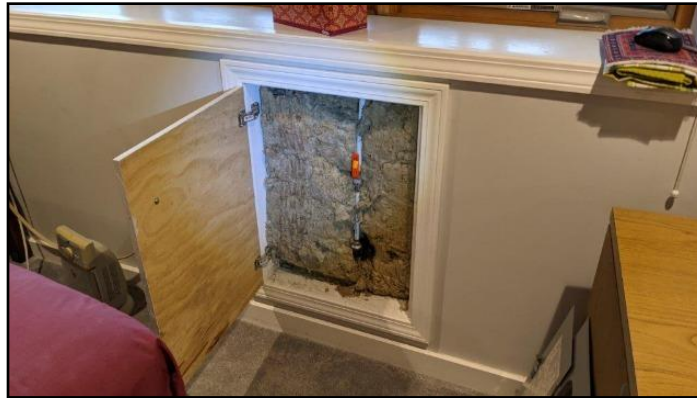
**39. Condition:** • [Missing](#)

Noted missing Pressure reducing valve at the main water shut off valve location.

This can result in higher water pressure in water supply piping coming from the street and develop leaks in piping connections throughout the house.

*PRV Missing*

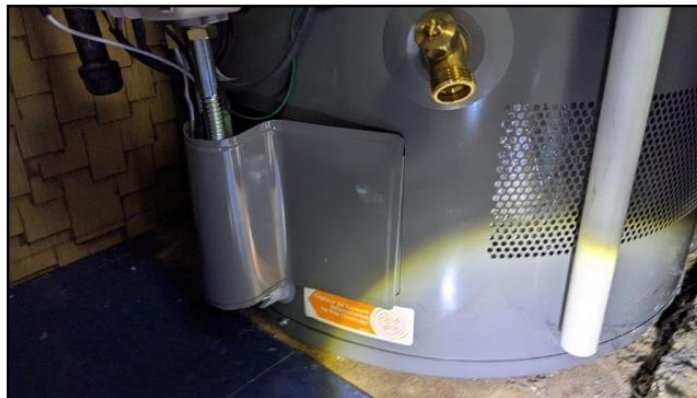
**40. Condition:** • Safety pan and drain missing

**Implication(s):** Chance of water damage to structure, finishes and contents

*Safety pan and drain missing*

**Task:** Provide

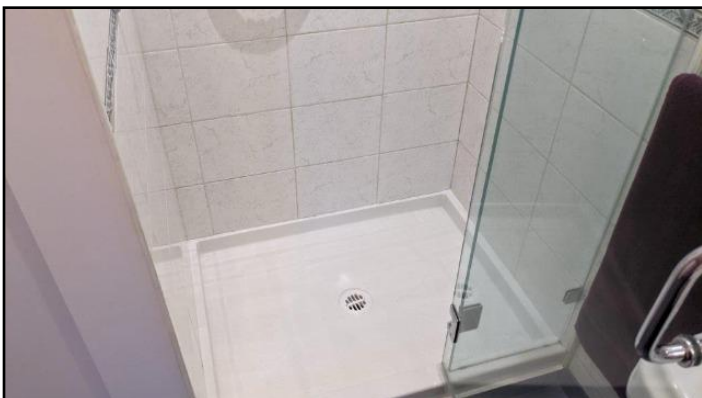
**41. Condition:** • Moisture detected

Cracked grout filler noted in the corner of shower stall with elevated moisture reading.

Moisture detected

Have general contractor to re grout tiles in shower stall.

General recommendation in bathrooms is to use caulking in any vertical/horizontal intersections wall/floors to stop potential water ingress.

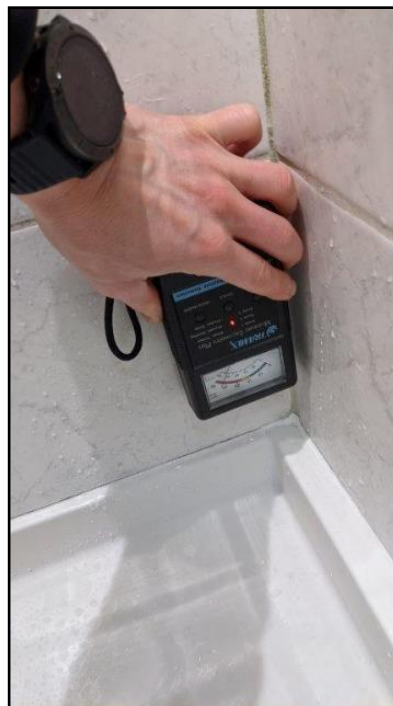
Moisture detected

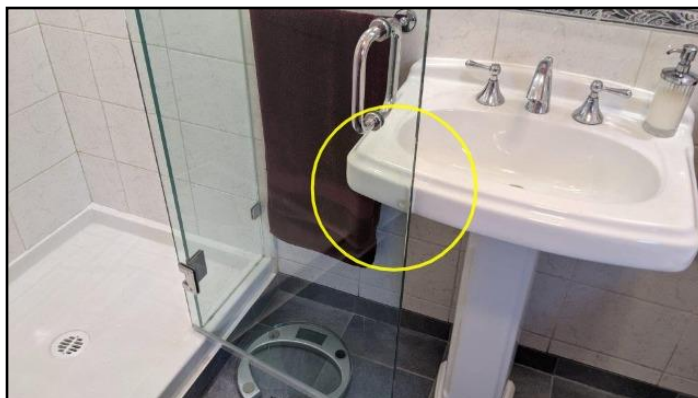
**42. Condition:** • Current layout in bathroom does not allow fully open shower stall door and is touching sink. with strong swing glass door could potentially break. Consult general contractor if any improvements can be done to provide safe operation of shower stall.

**Implication(s):** Chance of breaking glass door. Safety issue.

Glass door / Sink interference
