## Description

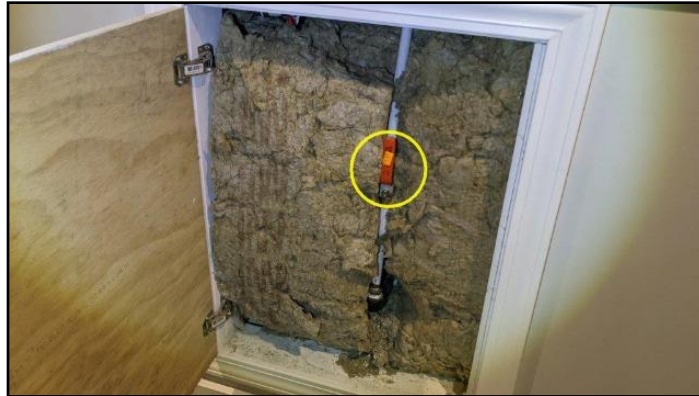
Main water shut off valve at the:

- West
- Basement

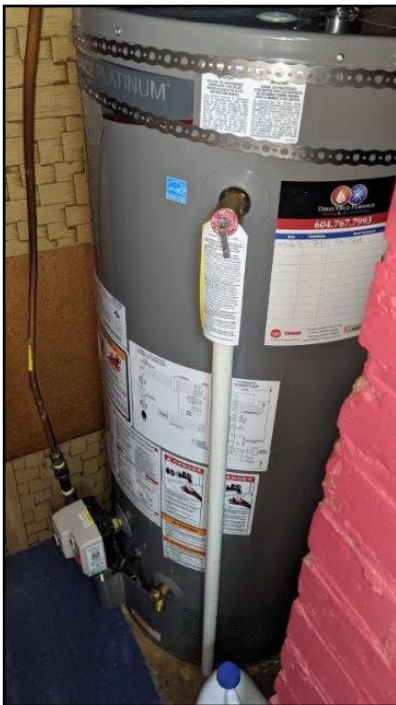
Conventional Water heater

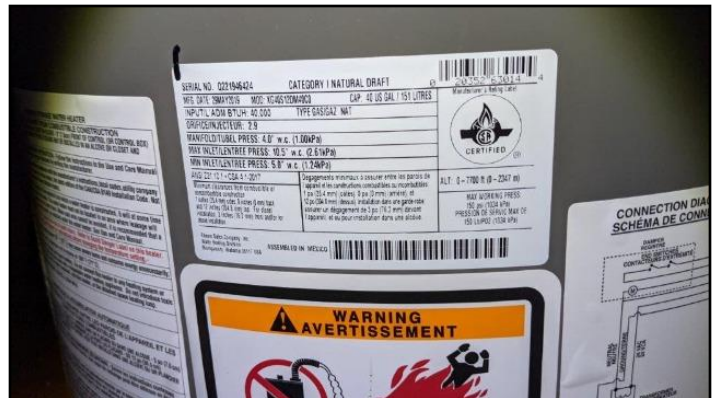
Data plate

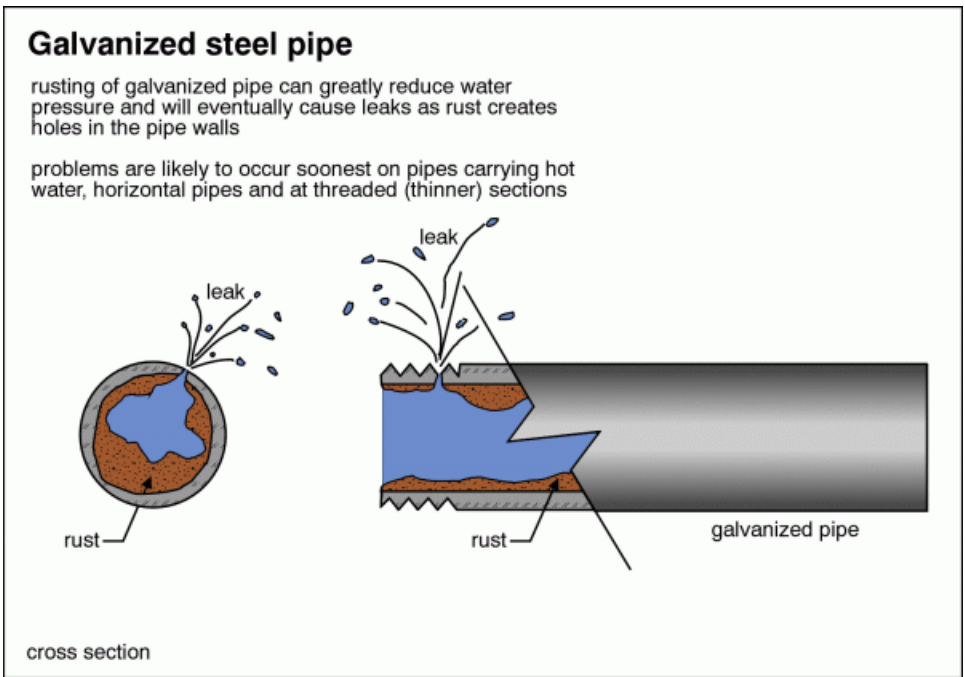
**37. Condition:** • [Galvanized steel](#)

Galvanized pipes are steel pipes that have been dipped in a protective zinc coating to prevent corrosion and rust. Galvanized piping was commonly installed in homes built before 1960. When it was invented, galvanized pipe was an alternative to lead pipe for water supply lines. Over time, the galvanized steel pipes begin to rust or corrode from the inside.

**Implication(s):** Reduced water pressure and volume

*Galvanized steel*

Have certified plumber evaluate the presence of galvanized steel material in water supply piping.

**Task:** Further evaluation

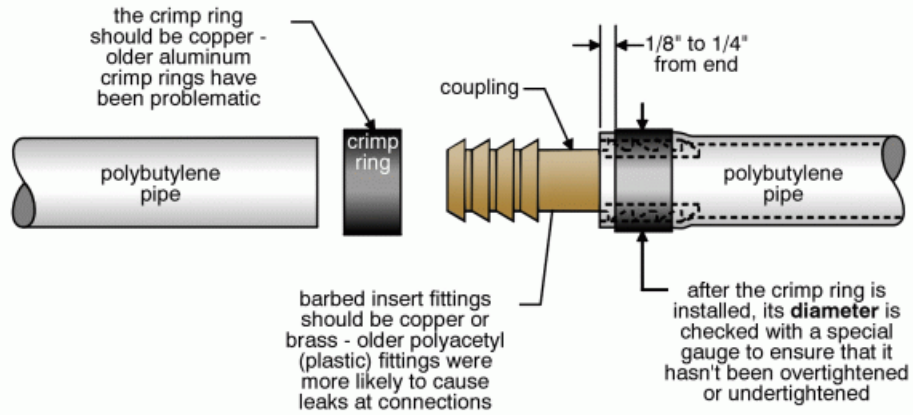
## Polybutylene pipe - crimp fitting

Noted in the basement bathroom under sink water supply polybutylene piping material. Poly B piping has a history of failing, consult a plumber regarding condition of piping and possible replacement. In addition, there may be possible insurance issue; consult with your insurance provider.

**Implication(s):** Chance of water damage to structure, finishes and contents | Leakage

**Task:** Further evaluation

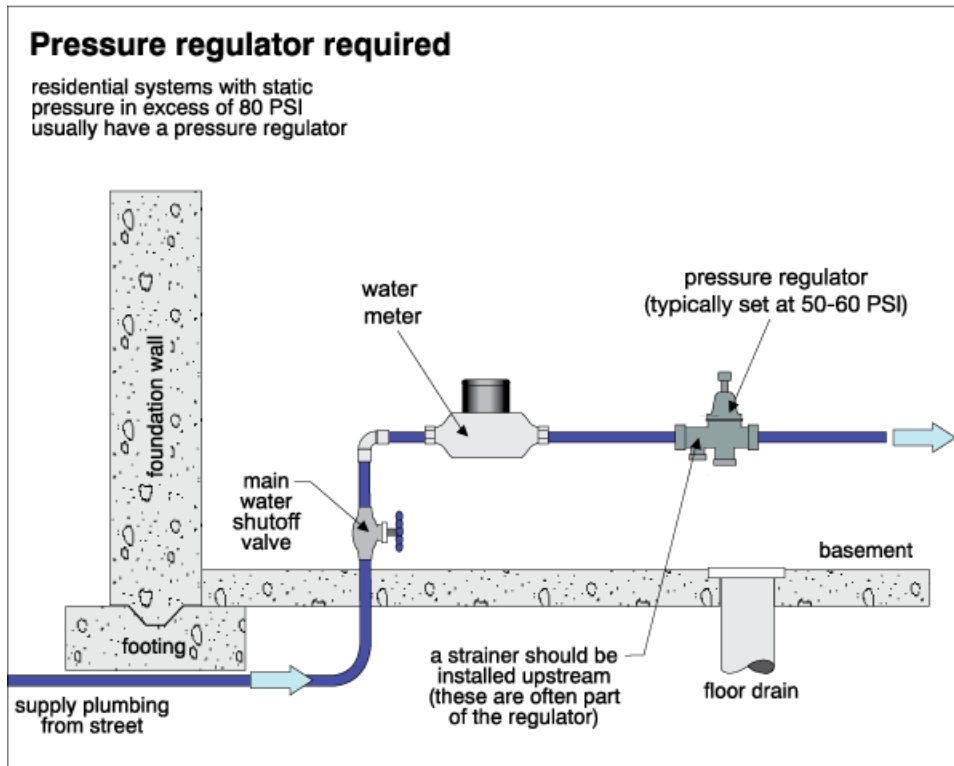
Noted missing Pressure reducing valve at the main water shut off valve location.

This can result in higher water pressure in water supply piping coming from the street and develop leaks in piping connections throughout the house.

**Implication(s):** Chance of water damage to structure, finishes and contents | Leakage | Damage to equipment

*PRV Missing*

**Task:** Further evaluation Provide
